## HOME INSPECTION REPORT

Prepared For Exclusive Use By  
**John and Jenny Right**

For The Property Located At  
**1234 Right Place, Rightville, WA 6123**

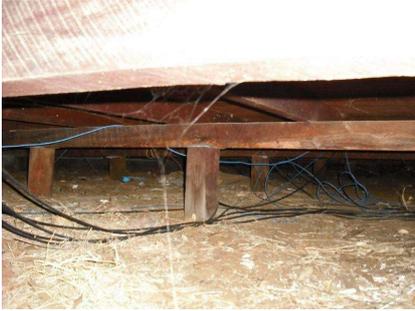
2.4 - COMMENTS: This residence has a raised foundation. Such foundations typically permit entry to a crawlspace beneath the home, providing convenient access to the water supply pipes, drain pipes, vent pipes, electrical conduits, and in some cases the heating/cooling system distribution ducting.

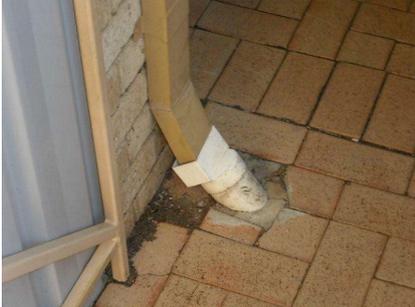
4.4 - COMMENTS: Surface drainage conditions within 3 metres of the inspected structure(s) appeared satisfactory.

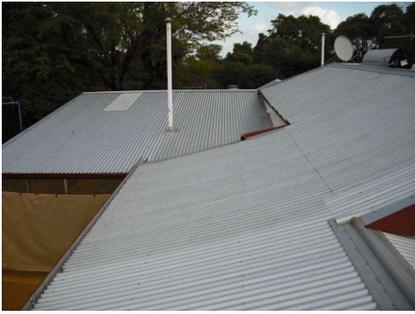
5.2 - COMMENTS: The metal roofing material appears to be in satisfactory condition relative to its age. The roof was not accessed or walked upon for the inspection.

5.3 - MAINTENANCE: Many of the screw fixings located on the roof sheeting are rusty and should be replaced in due course.

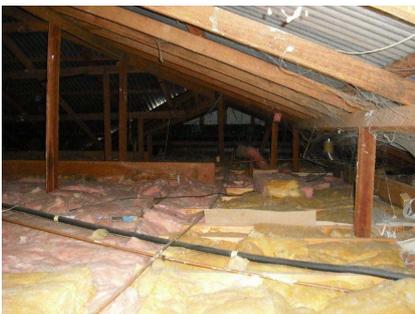
6.1 - COMMENTS: The ceiling is insulated with fiberglass batts insulation, which should be adequate.

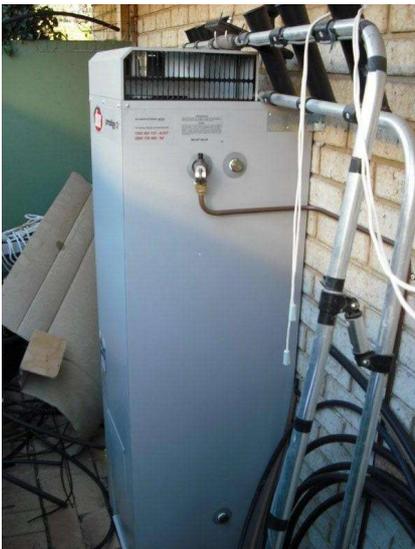
8.3 - COMMENTS: There is a storage gas hot water system located on the west side of the home.

8.4 - COMMENTS: The water heater was functioning satisfactorily at the time of the inspection, with no evidence of prior or active leakage observed.
